CLEAN WATER ACT  
COMPLIANCE INSPECTION

Investigation Date(s)

On-Site June 15, 2011

Fly-over November 9, 2010

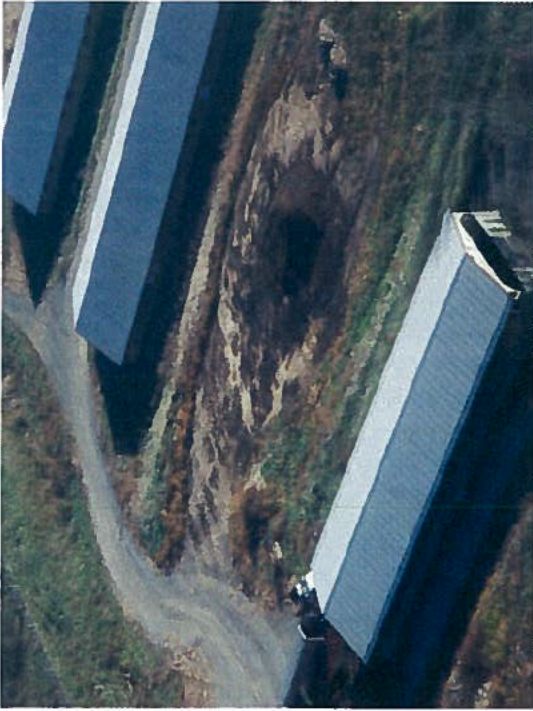
2010-11-09--15.16.26

On November 9, 2010, Mahri Monson and Rebecca Crane of the United States Environmental Protection Agency (EPA) conducted a fly-over reconnaissance inspection of the poultry operation located at [REDACTED] Mathias, WV 26812 (the "Facility"). Photographs were taken in the area of the Facility and are attached (see Appendix A). A pile of uncovered material near a poultry house is shown in Photo 2010-11-09--15.16.26.
